IPC-9691A

# **User Guide for the IPC-TM-650, Method 2.6.25, Conductive Anodic Filament (CAF) Resistance Test (Electrochemical Migration Testing)**

Developed by the Electrochemical Migration Task Group (5-32e) of the Cleaning and Coating Committee (5-30) of IPC

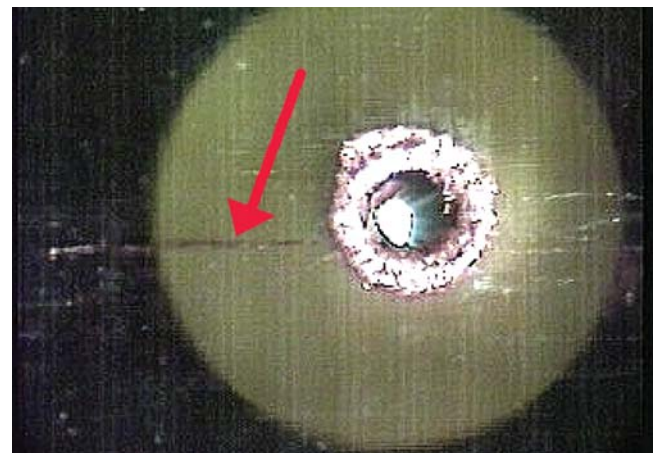
Figure 4-1 Conductive Filament Example<sup>a</sup>

The high magnification photo, Figure 4-1 below, shows a PCB with layer 1 (top layer) removed, revealing a near shorting condition between the plated through hole and layer 2 ground plane.

Where large conductive filament growth is visible under a microscope, often there is some adjacent laminate material fracturing or defect that contributed to its formation. Examples of such visible filament growth follow. Only Figure 4-3 may show a true atacamite filament, however all examples shown in Figures 4-1, 4-2 and 4-3 would fail the temperature, humidity, and bias conditions selected to determine multilayer board reliability between internal features.
